TECHNICAL DATA SHEET

COATINGS

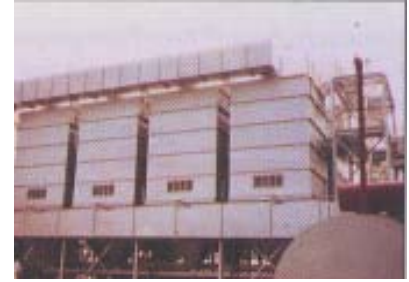
Outward appearances can conceal.....

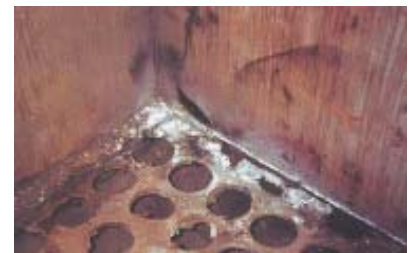
Interior conditions reveal.....

Midwesco Filter has been involved with dozens of baghouses where modest to severe interior corrosion required action by our customer to salvage the integrity of the remaining steel. Metal thickness tests revealed as much as 40-50% of the original steel thickness was deteriorated, this much damaged required total steel replacement. However, 20-25% damage was salvaged with proper blast cleaning techniques and interior coatings.

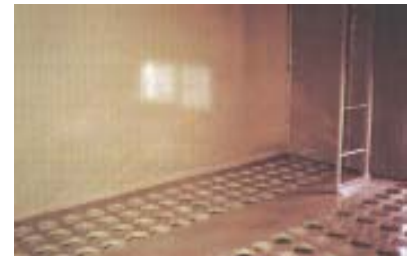
The need for baghouse coatings by Midwesco.

Midwesco Filter has applied baghouse interior and hopper coatings that ranged from simple brushing, to spray, and to art of the trowel. Each project was evaluated for conditions like operating temperature, cycle swings/excursion, chemistry, corrosion vs. erosion, and level of steel deterioration. Each project completed by Midwesco Filter has a demonstrated success story.
